V.C. SUMMER NUCLEAR STATION

VISUAL IMPACT ASSESSMENT OF HISTORIC PROPERTIES

VCS2-Lake Murray 230 kV Line No. 2

VCS2-St. George 230 kV Line No. 1

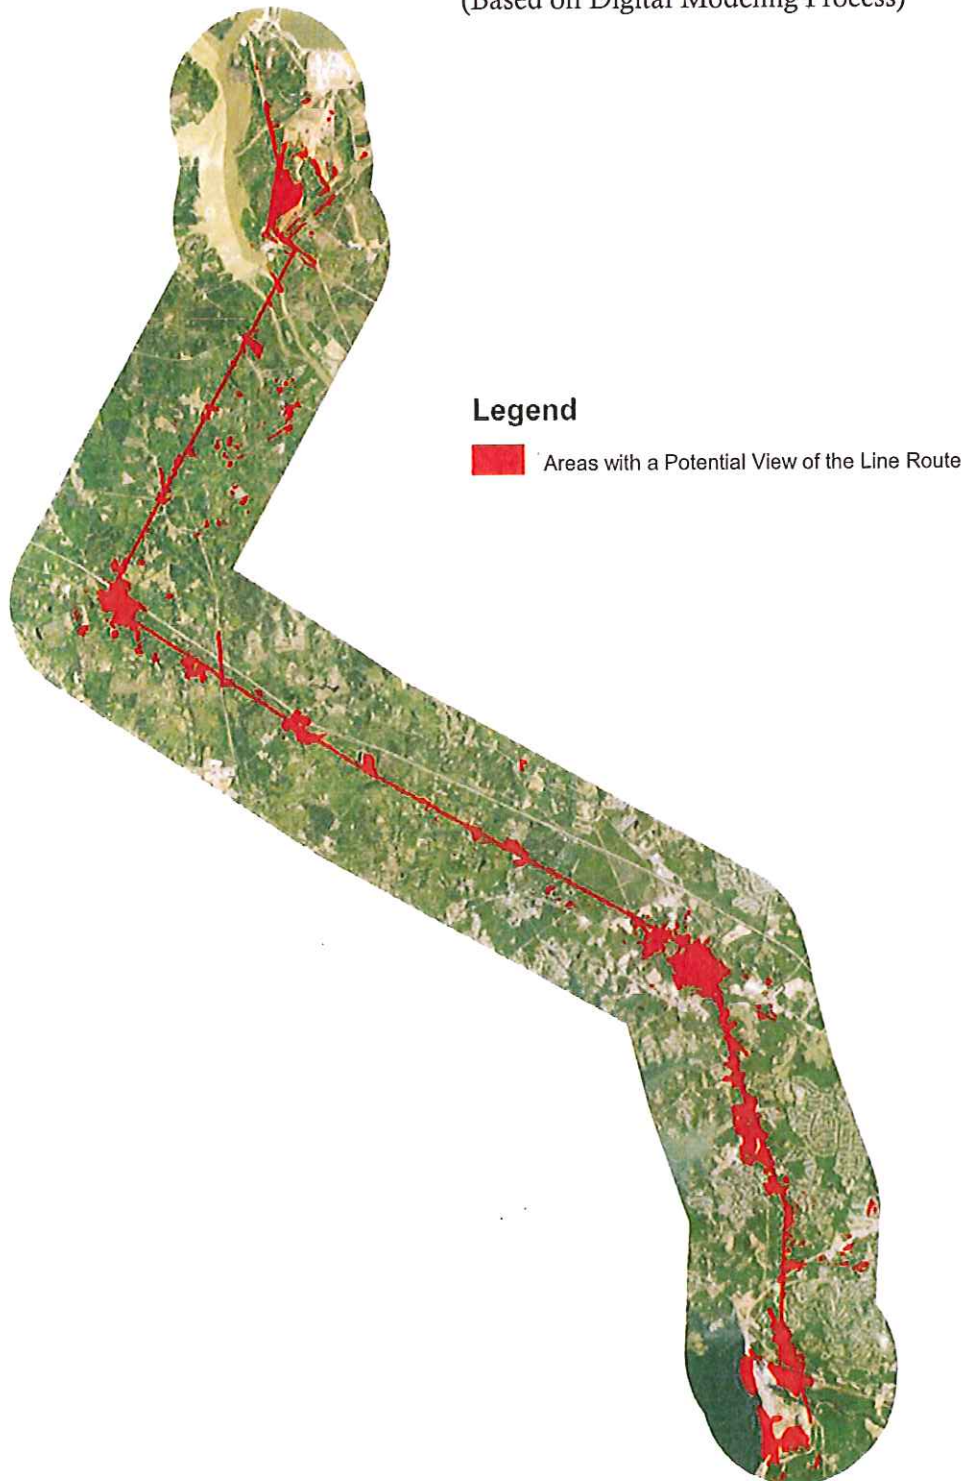
Areas with a Potential View of the Line Route

(Based on Digital Modeling Process)

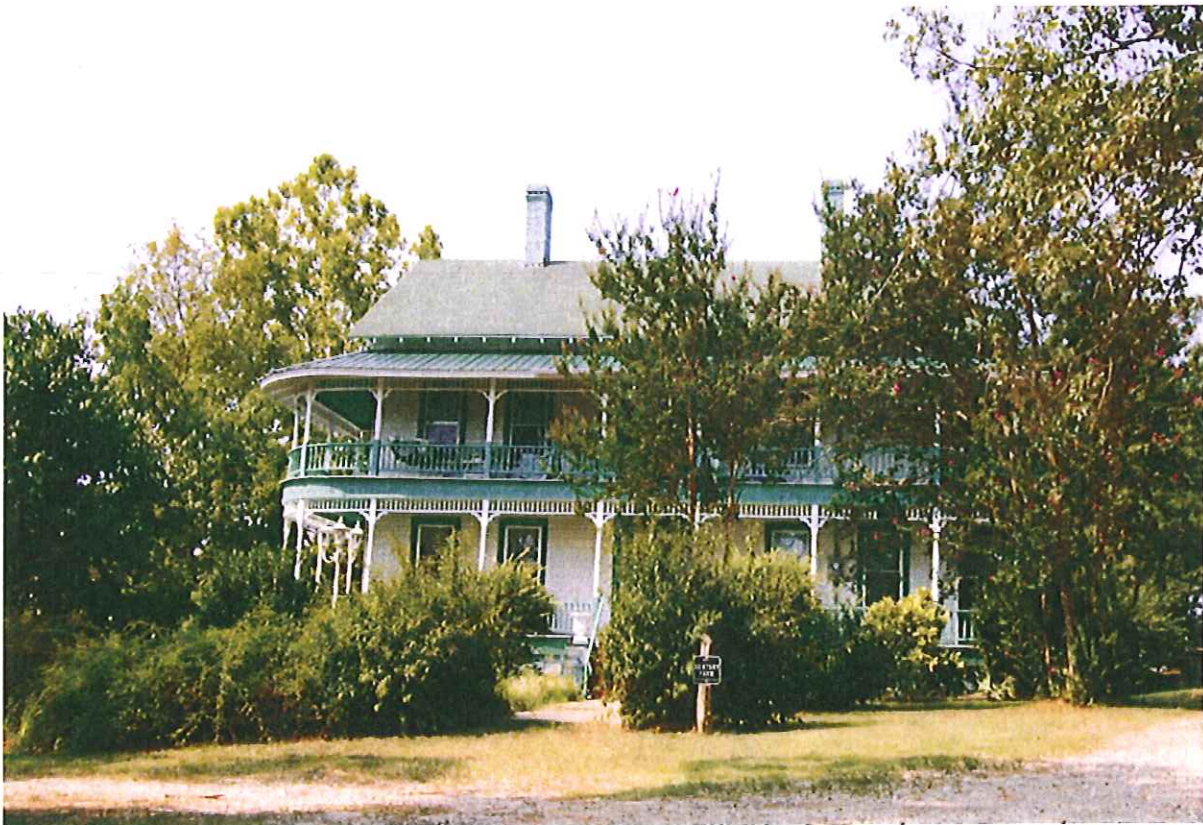
Historic Site: Koon, John Jacob Calhoun Farmstead (Site Number 4731.00)

Field Visit & Analysis: Due to heavy foreground screening, it was determined that the Koon, John Jacob Calhoun Farmstead would not have a probable view of the proposed VCS2-Lake Murray 230 kV Line No. 2/St. George 230 kV Line No 1. Also, it is unlikely that the line route would be able to be seen from any point on the property. As a reference, only the top 10+/- feet of the cell tower to the southwest could be seen over the trees.

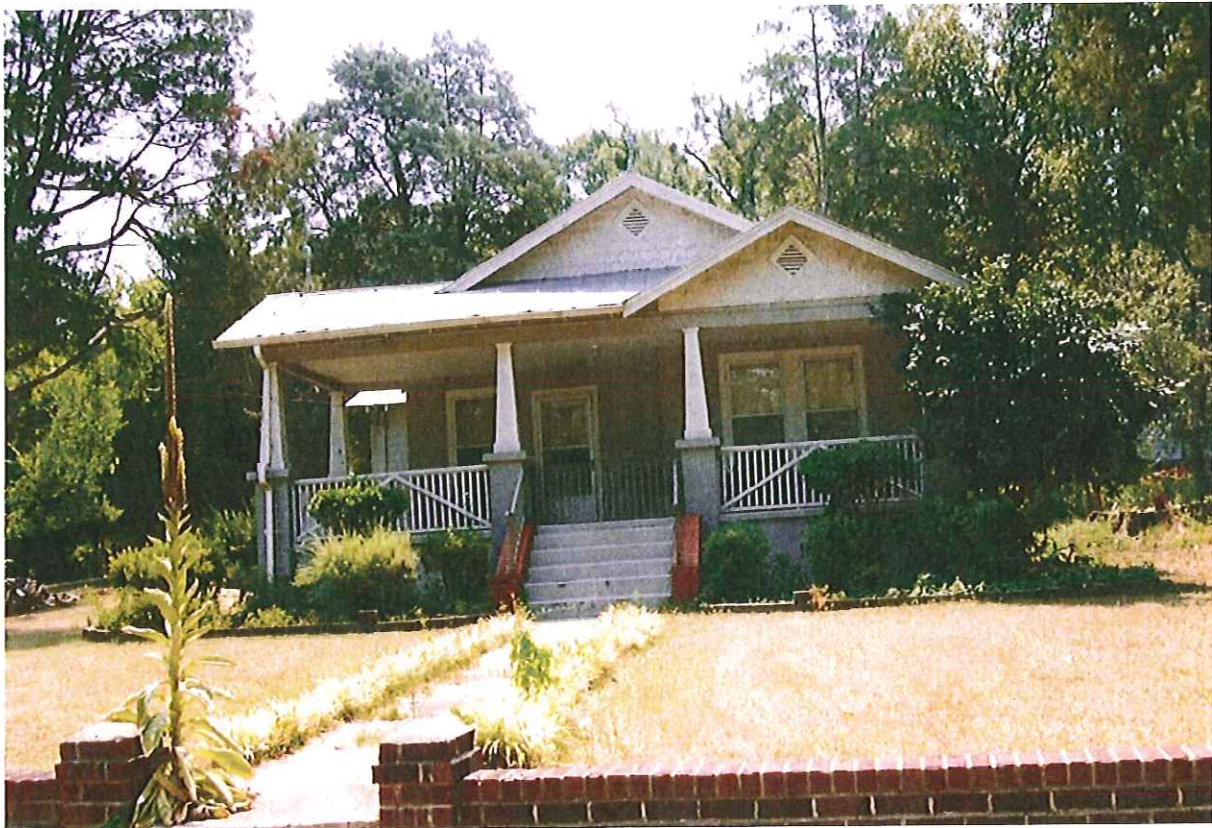
Historic Site: (Site Number 243-0288)

Field Visit & Analysis: Light foreground and moderate mid-ground screening, existing conductors are visible, a filtered view of the line through the pine/hardwood forest is probable in leaf-off conditions.

Resource	NHRP Status	Windshield Survey Determination	Distance from Future Line (Miles)	Screening Condition	BLM Total Scenic Quality Score	Likely Visual Effect of Future 230 kV Line
243-0288 (House)	Not Eligible	Eligible	0.1	HM	14	Will likely not be evident to casual viewers due to foreground and mid-ground screening
Ballentine, Eusebius and Jenny Boozer House	Eligible	Eligible	0.22	HF	14	Slight view may be possible from 2nd story of house, but will be insignificant
Bethel Lutheran Church	Not Eligible	Eligible	0.51	HM	2	Will have no view
CSX Railroad Bridge	Potentially Eligible	Potentially Eligible	0.19	HF	14	A slight, insignificant view may be possible during leaf-off conditions
Harry Easterling Bridge	N/A	Potentially Eligible	0.87	HM	16	Conductor spanning the Broad River may be visible but, due to distance, will not be evident to casual viewers
Lindler House	Eligible	Eligible	0.58	HM	14	Current view found in direction of future line is highly modified; views of future line, if any, will not be evident to casual viewers

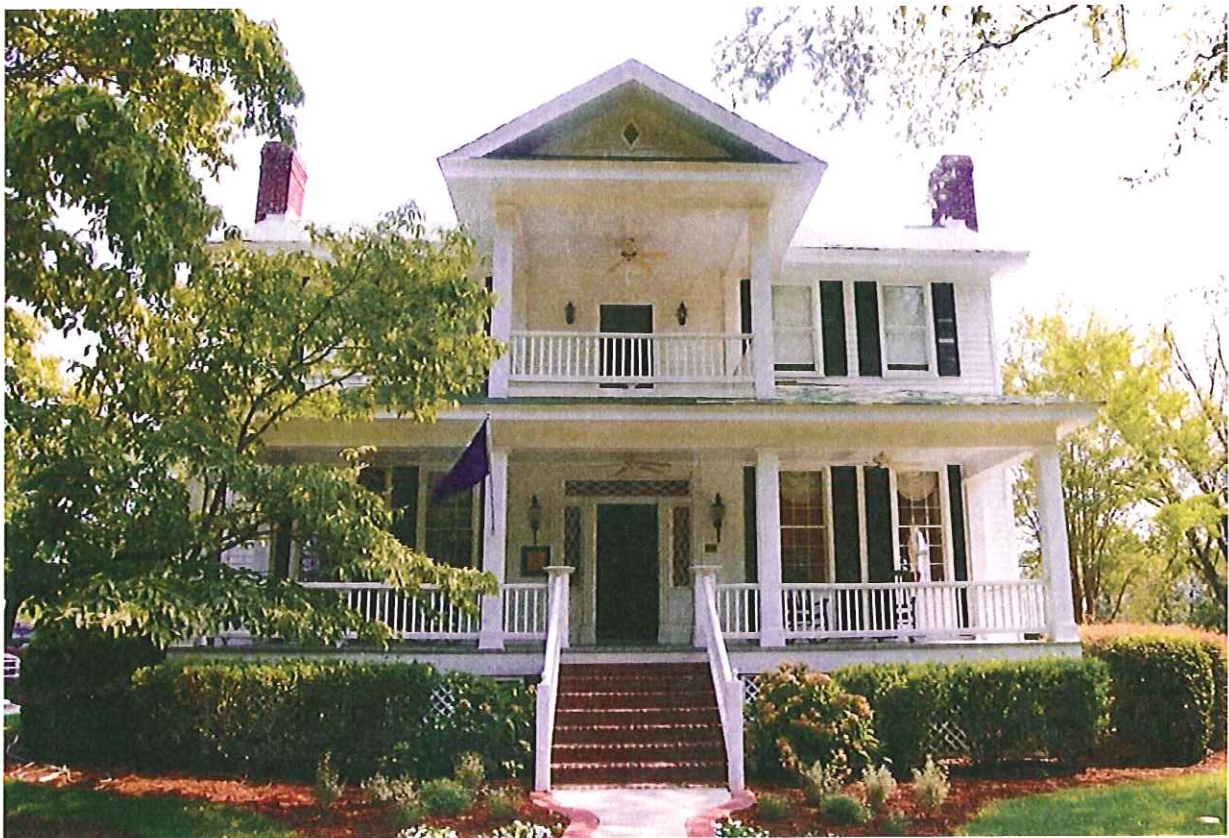
Historic Site: George Lorick Plantation House (Site Number 243-0178)

Field Visit & Analysis: Mid-ground screening by newly constructed apartment buildings; numerous other existing transmission structures and utilities are visible down N Lake Drive.

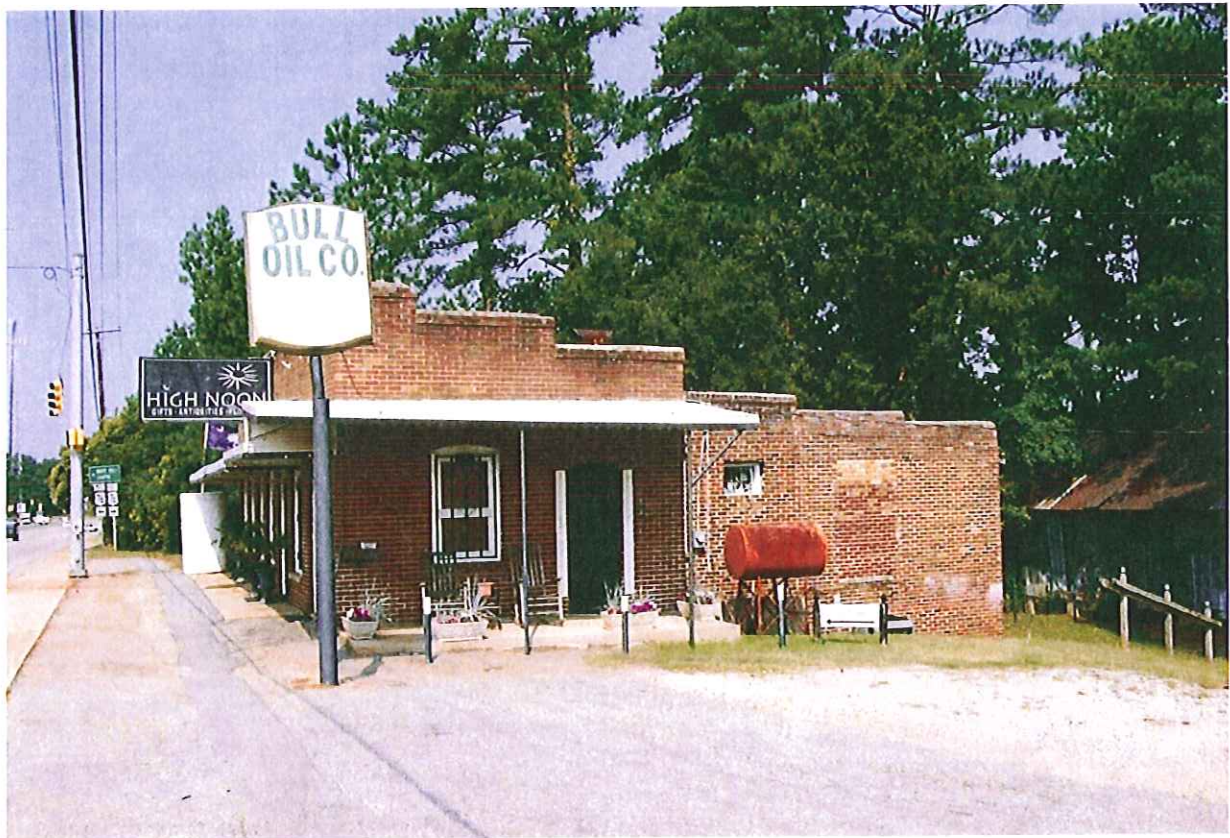
Historic Site: Ballentine Store/Bull Oil Company (Site Number 426-4717)

Field Visit & Analysis: Heavy foreground screening, view of the line route is not probable; area is highly commercialized with a number of utilities, including light poles, electrical lines, a railroad, etc.

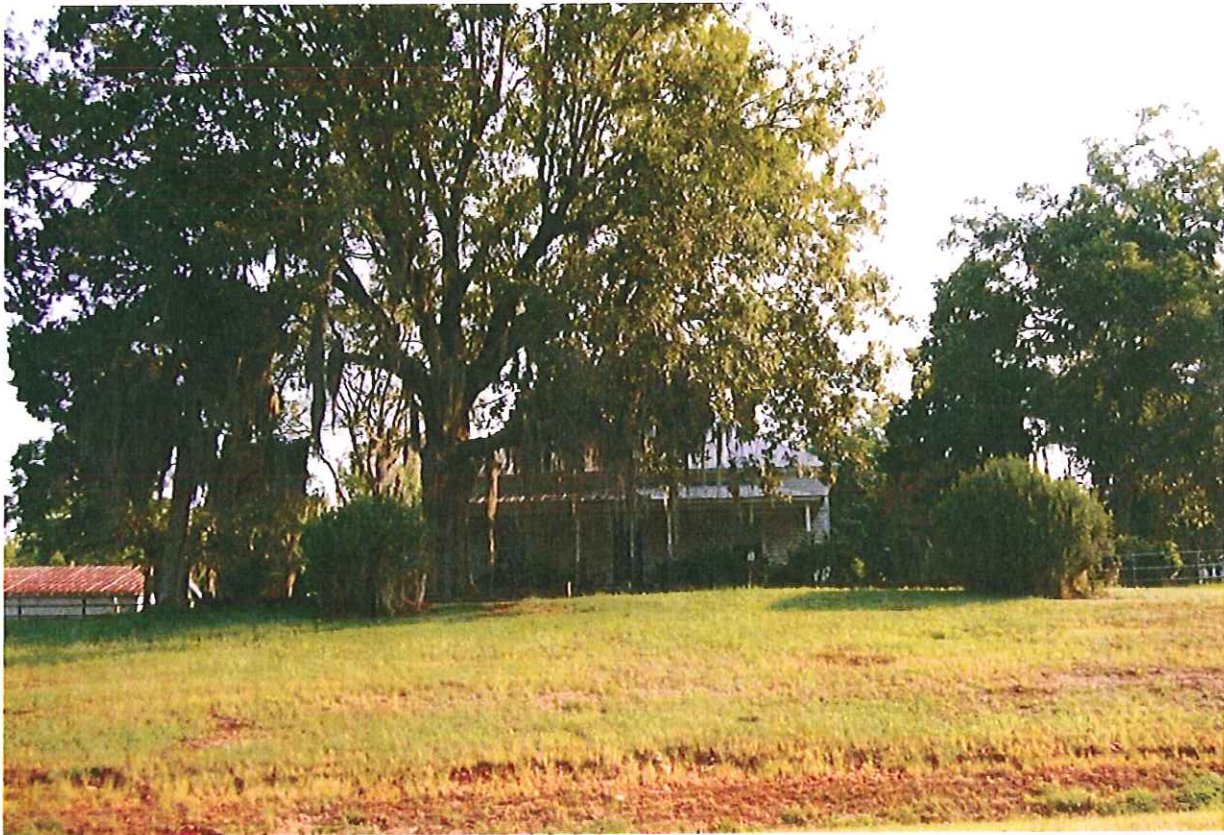
Field Visit & Analysis: Heavy foreground screening; line route will not be visible.

Conclusion Based on the Visual Impact Assessment and Field Visit: No View

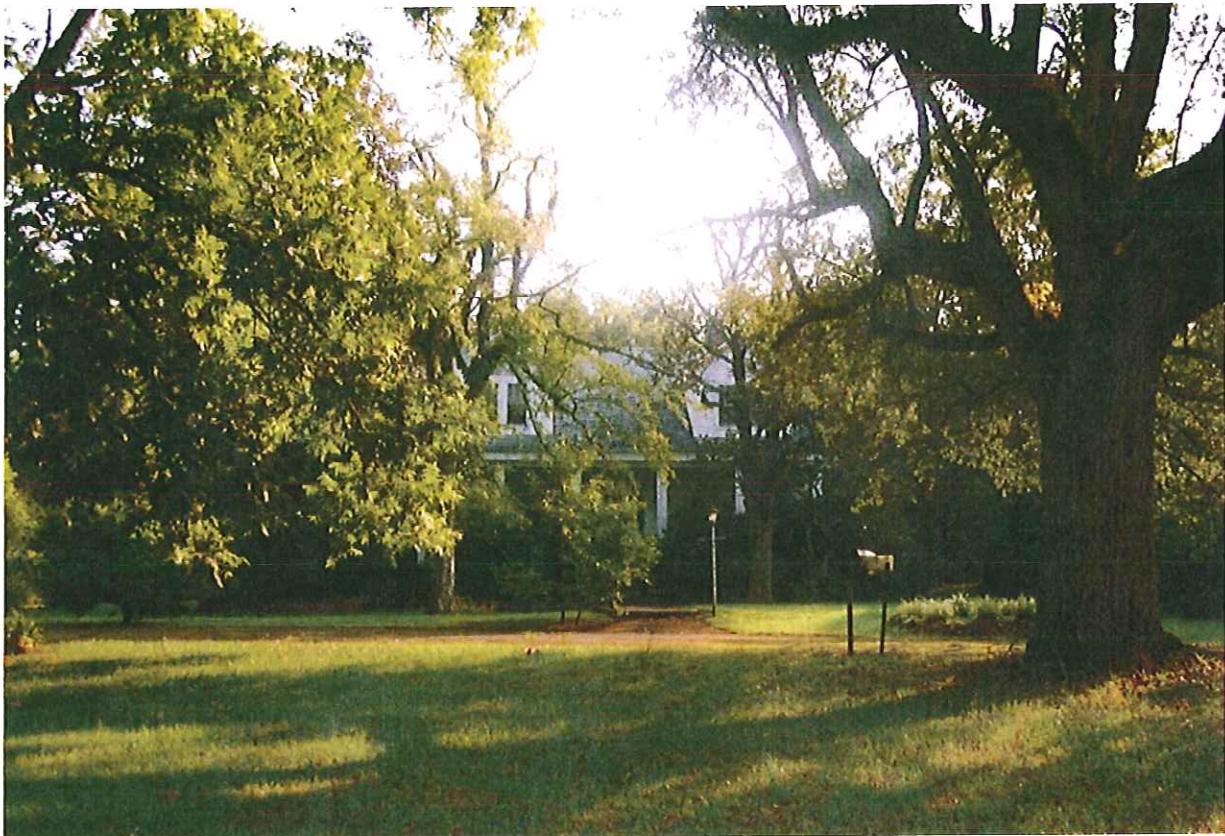
Historic Site: (Site Number 1098)

Description: White house with mature live oaks in the front yard

Distance from Line Route: 1.03 miles / 1.66 kilometers

Field Visit & Analysis: Heavy foreground screening; line route will not be visible.

Conclusion Based on the Visual Impact Assessment and Field Visit: No View

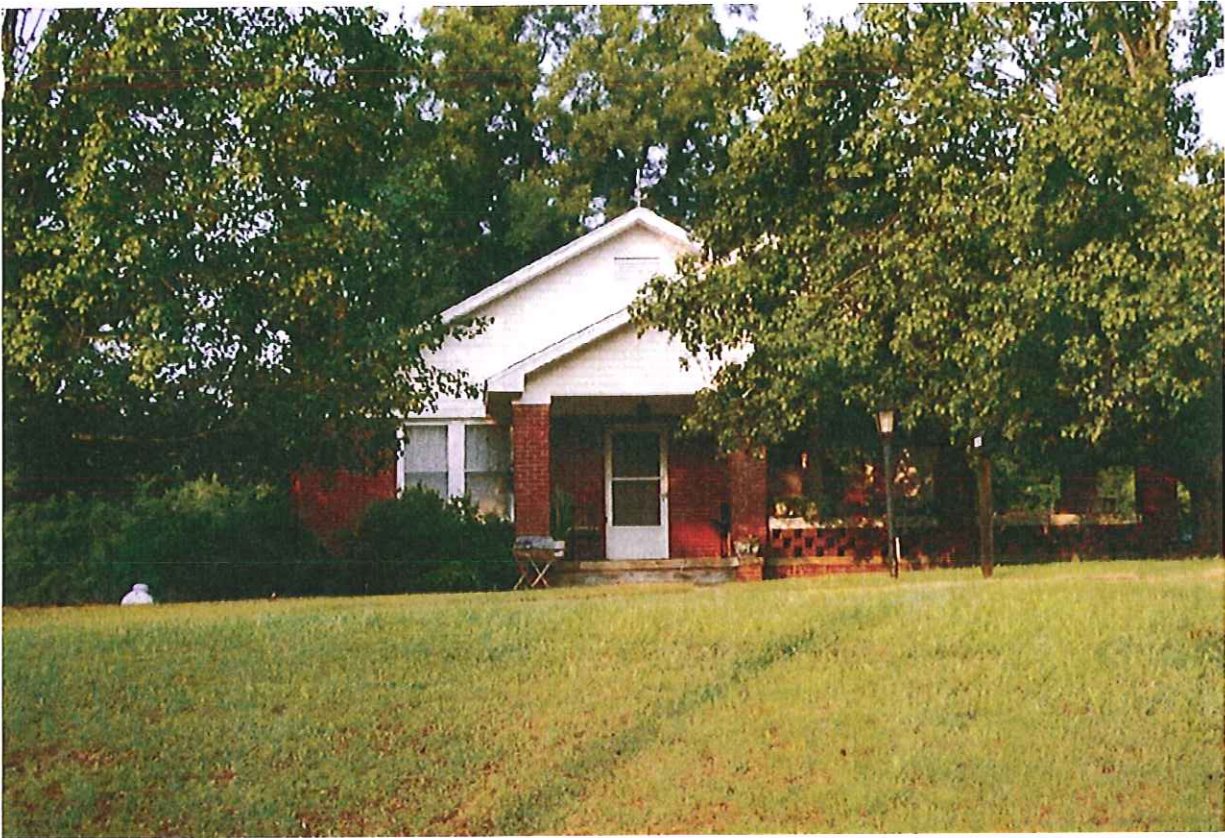
Historic Site: (Site Number 1201)

Description: One-story brick house

Distance from Line Route: 0.8 miles / 1.31 kilometers

Field Visit & Analysis: Heavy foreground and mid-ground screening; line route will not be visible.

Conclusion Based on the Visual Impact Assessment and Field Visit: No View

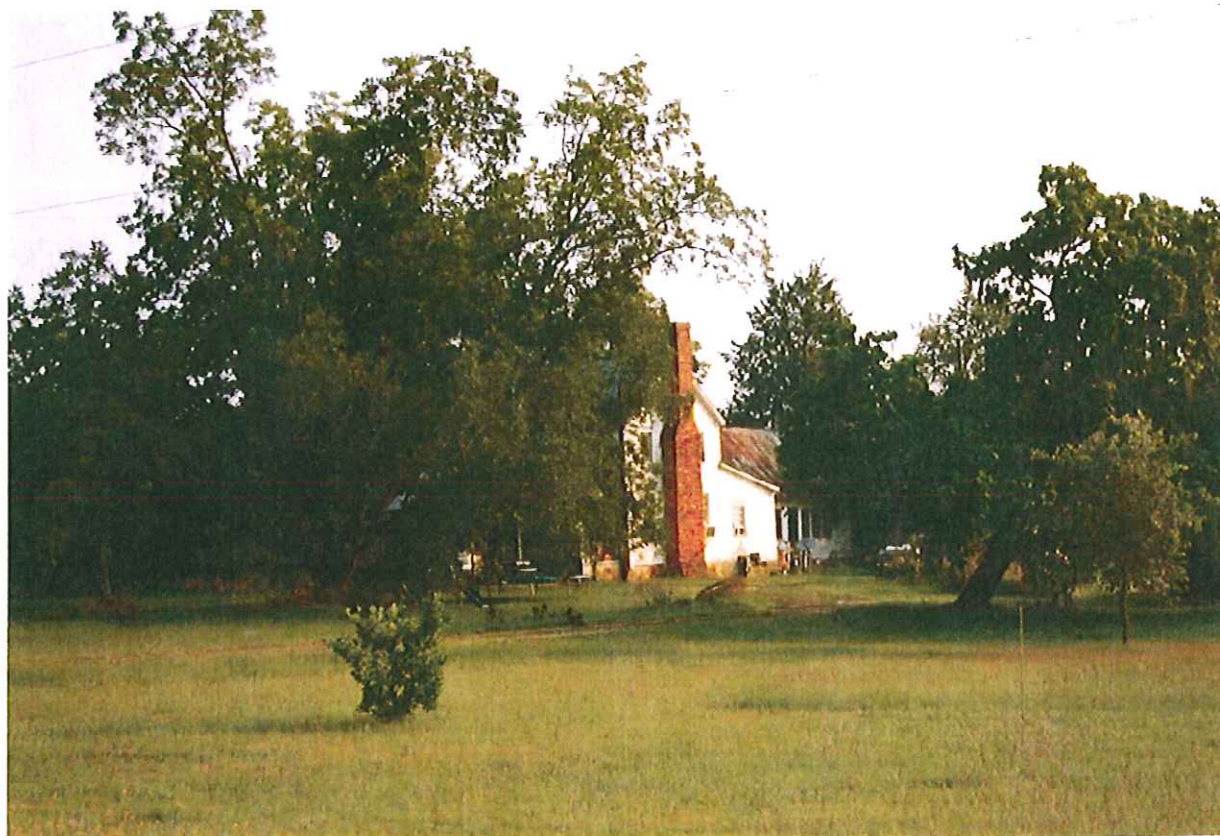
Historic Site: (Site Number 1200)

Description: Two-story white farmhouse with double chimney

Distance from Line Route: 1.16 miles / 1.86 kilometers

Field Visit & Analysis: Light foreground and heavy mid-ground screening; line route will not be visible.

Conclusion Based on the Visual Impact Assessment and Field Visit: No View

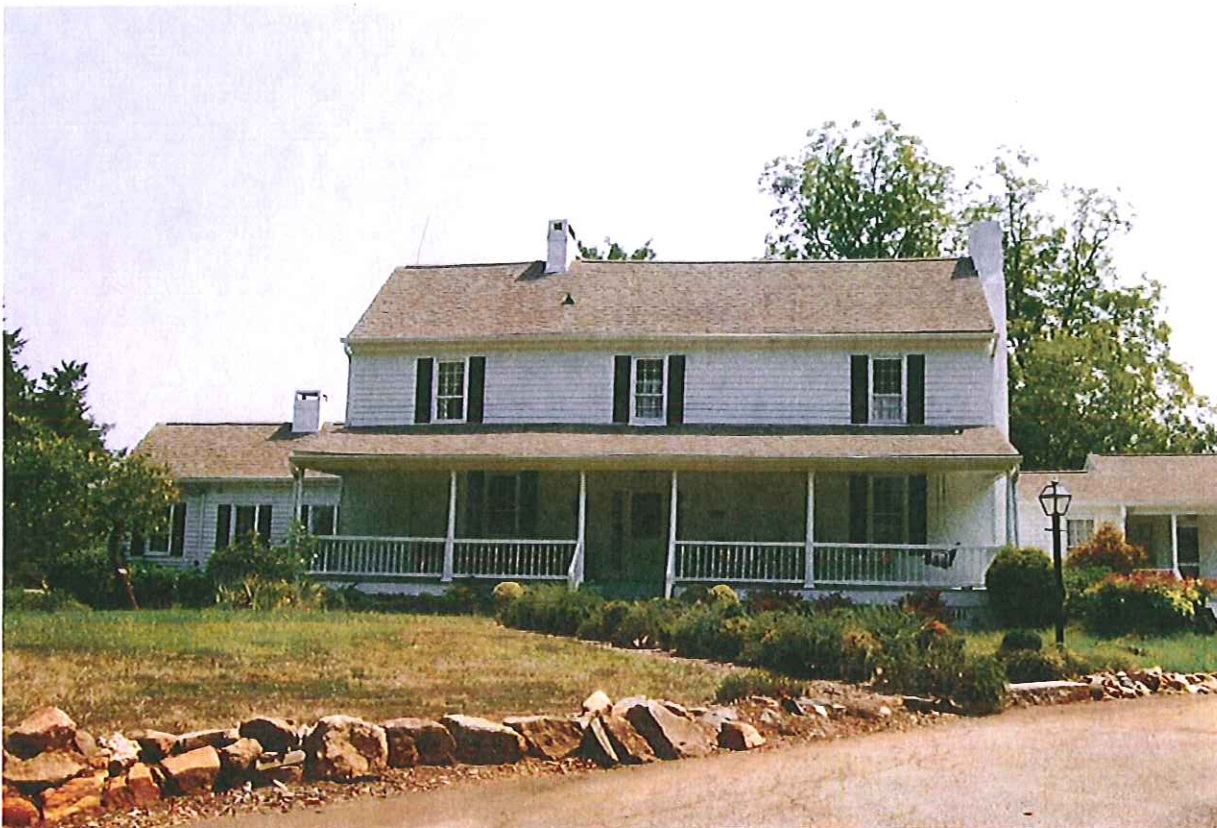
Historic Site: Selwood (Site Number 243-0126)

Description: Two-story white house, 3 residences on property

Distance from Line Route: 0.15 miles / 0.23 kilometers

Field Visit & Analysis: Moderate mid-ground screening; line route will not be visible in the summer months; due to close proximity of the line route and the depth of the forest cover, a filtered view of the line route is possible during leaf-off conditions.

Conclusion Based on the Visual Impact Assessment and Field Visit: Possible insignificant view through tree canopies during leaf-off conditions

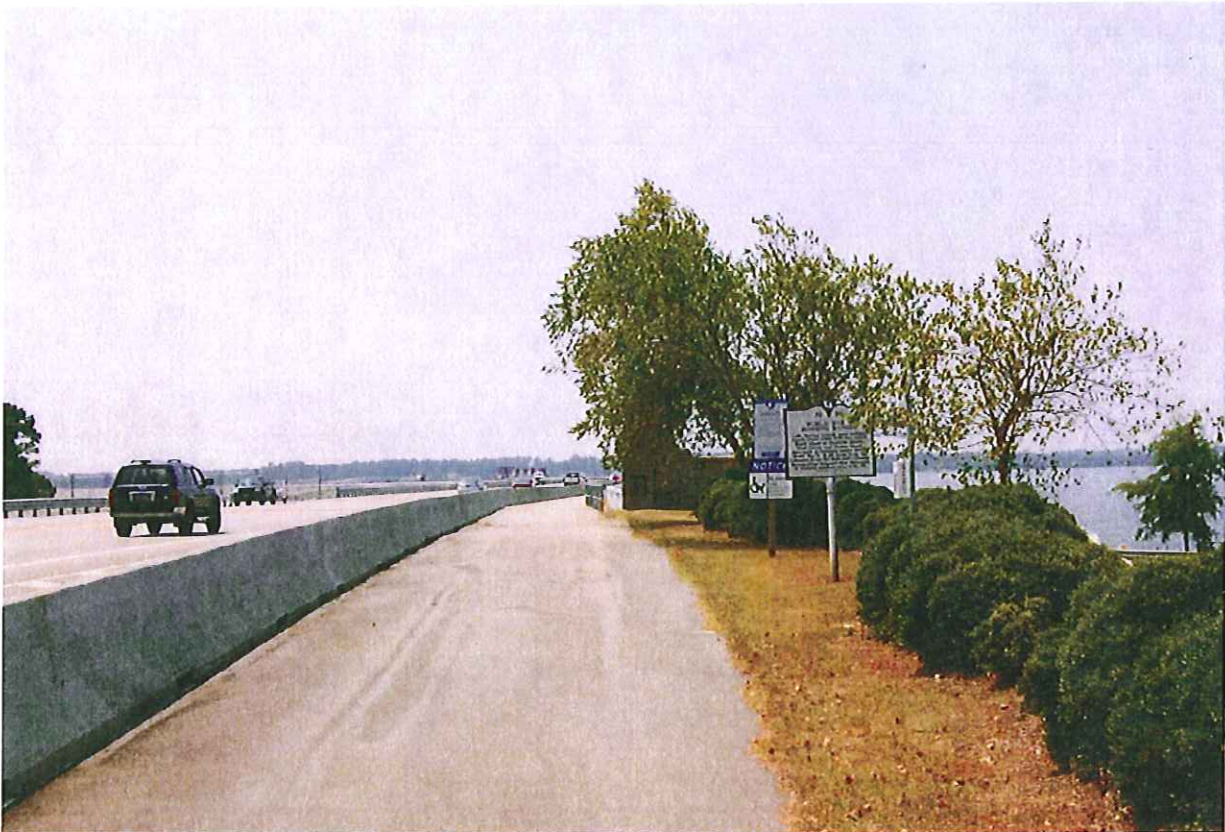
Historic Site: Saluda Dam & Power House Complex (Site Number 243-0127)

Description: Early 20th century earthen dam and power house complex that create Lake Murray

Distance from Line Route: 0.44 miles / 0.71 kilometers

Field Visit & Analysis: The line route will likely be visible from the southbound lane on Saluda Dam, but will not be visible from the northbound lane due to the low elevation and screening from a large wall. The proposed line route would not likely have any additional negative effects on the historical qualities of the dam due to the current visibility of utility structures.

Conclusion Based on the Visual Impact Assessment and Field Visit: Insignificant view due to current modifications resulting from electrical transmission and generation facilities

Saluda Dam and Power House Complex	Eligible	Eligible	0.44	LM	14	Views of the line as it enters the Lake Murray Substation will exist; however, due to current modifications resulting from electrical transmission and generation facilities, the change in visual conditions will be insignificant
Selwood (Multiple Structures)	Eligible	Eligible	0.15	HF	14	A view of the future line may be possible during leaf-off conditions; however, it will be insignificant, diffused by tree canopies, and will likely not be visible to casual viewers

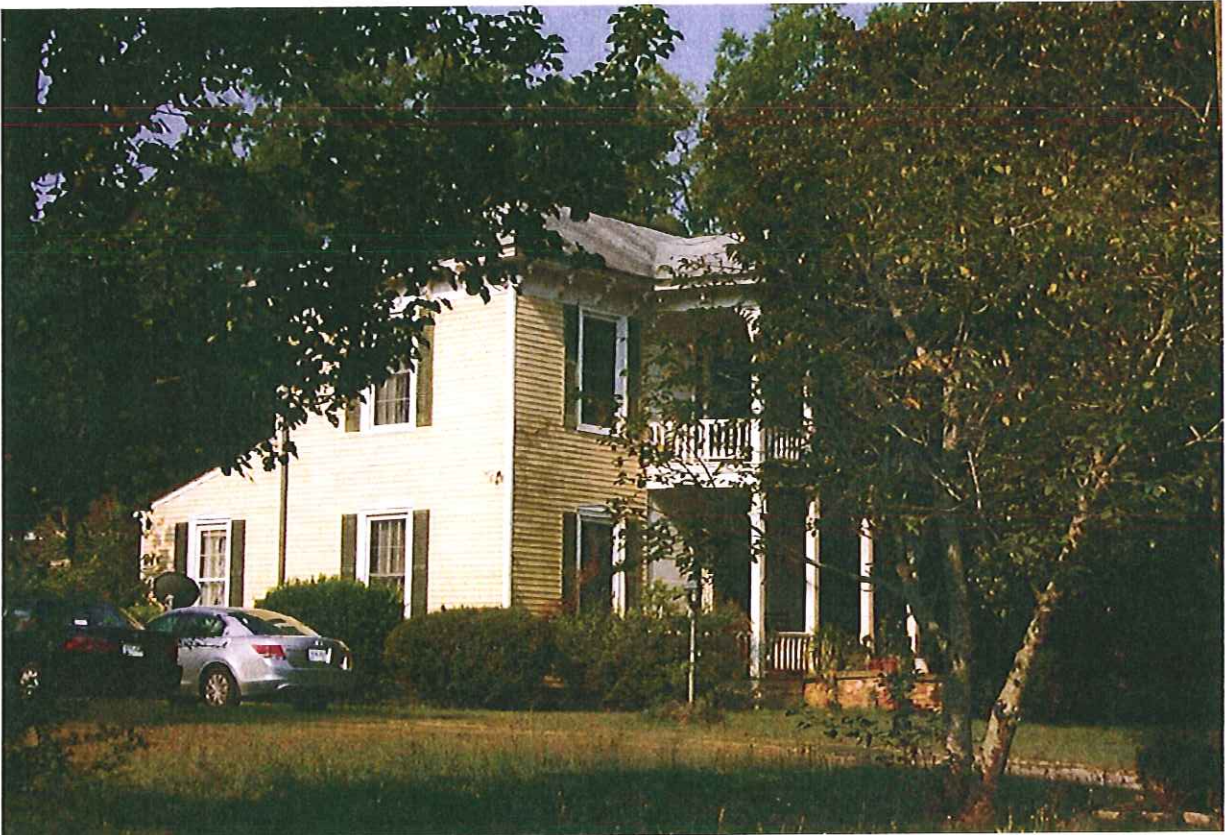
Historic Site: Eargle-Willingham House (Site Number 4955.00)

Description: Two-story yellow house

Distance from Line Route: 0.95 miles / 1.54 kilometers

Field Visit & Analysis: Heavy foreground screening; line route will not be visible.

Conclusion Based on the Visual Impact Assessment and Field Visit: No View

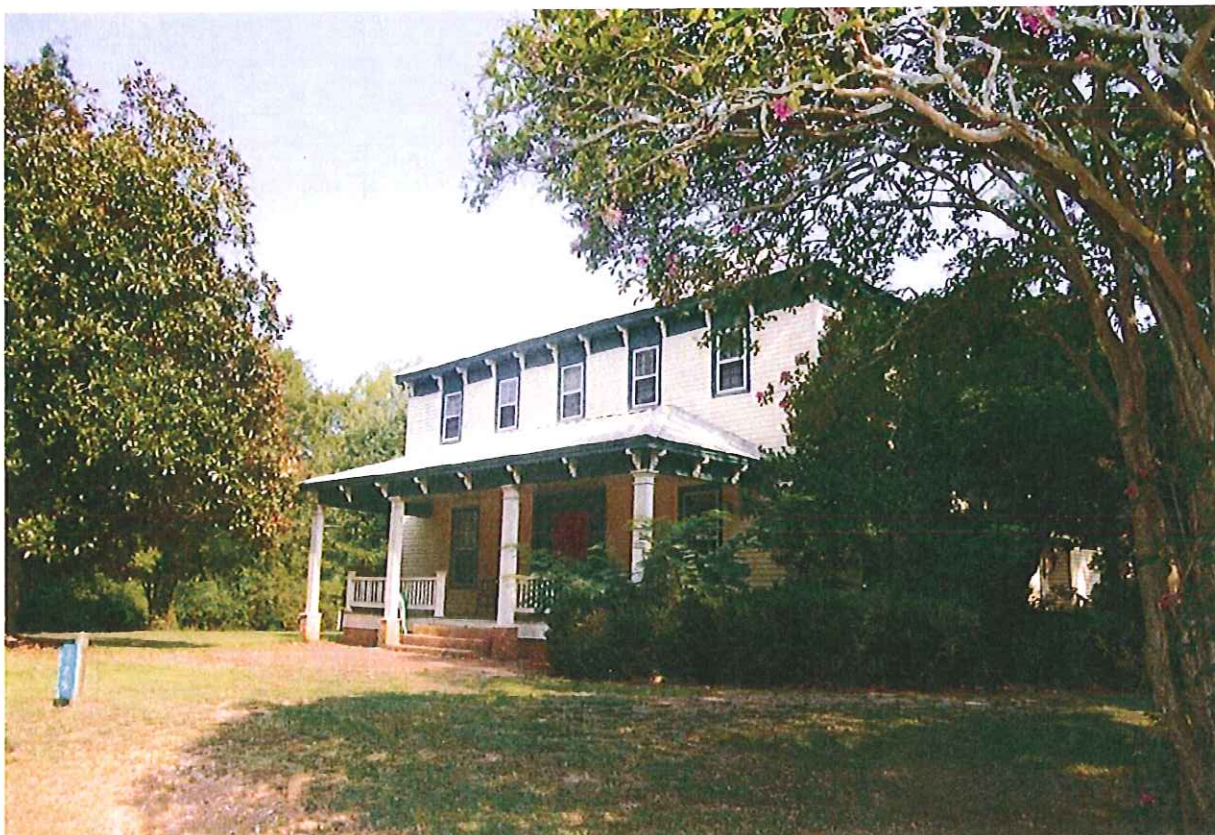
Historic Site: Eleazer House (Site Number 4950.00)

Description: Two-story yellow house, possibly used for commercial purposes

Distance from Line Route: 0.39 miles / 0.64 kilometers

Field Visit & Analysis: Heavy foreground screening; line route will not be visible.

Conclusion Based on the Visual Impact Assessment and Field Visit: No View

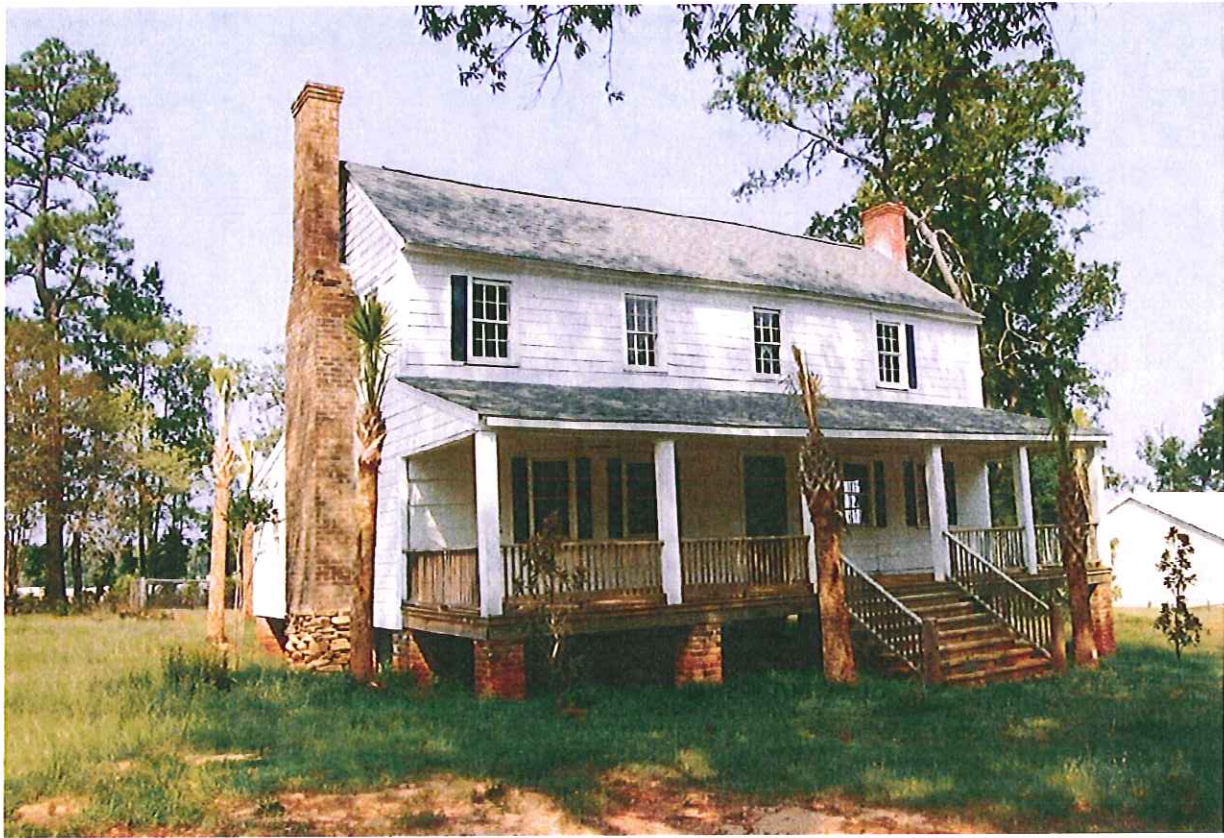
Historic Site: Lindler House (Site Number 5046.00)

Description: Two-story white house

Distance from Line Route: 0.58 miles / 0.93 kilometers

Field Visit & Analysis: Heavy mid-ground screening reduces the likelihood of having a view of the line route. While no existing structures were seen, the long vistas provide an opportunity for potential visibility.

Conclusion Based on the Visual Impact Assessment and Field Visit: Views of future line, if any, will not be evident to casual viewers

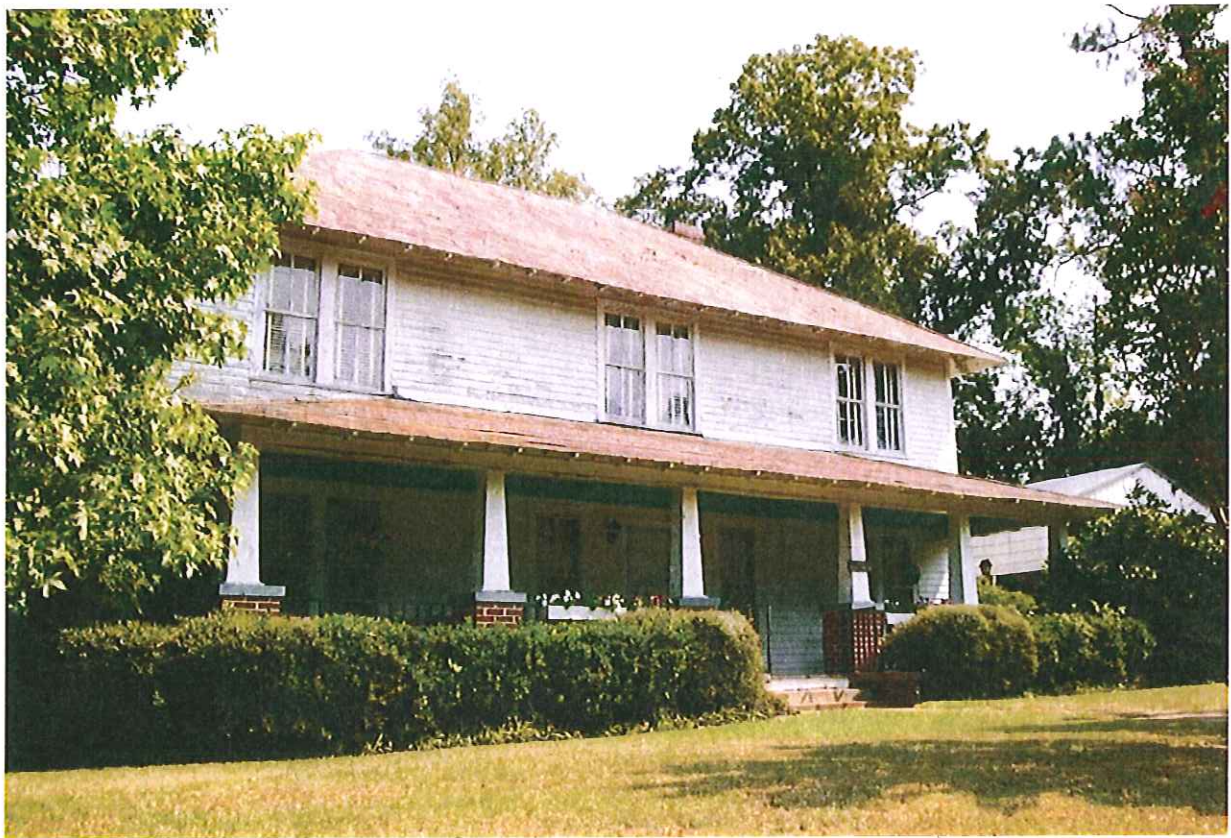
Historic Site: Ballentine, Eusebius and Jenny Boozer House (Site Number 4715)

Description: Two-story white house

Distance from Line Route: 0.22 miles / 0.36 kilometers

Field Visit & Analysis: Heavy foreground screening, view of the line route is not probable in the warmer months; however, due to a deciduous forest cover and the close proximity of the line route, it may be visible during winter months as the leaves drop.

Conclusion Based on the Visual Impact Assessment and Field Visit: Slight, insignificant view is possible from 2nd story of house during leaf-off conditions

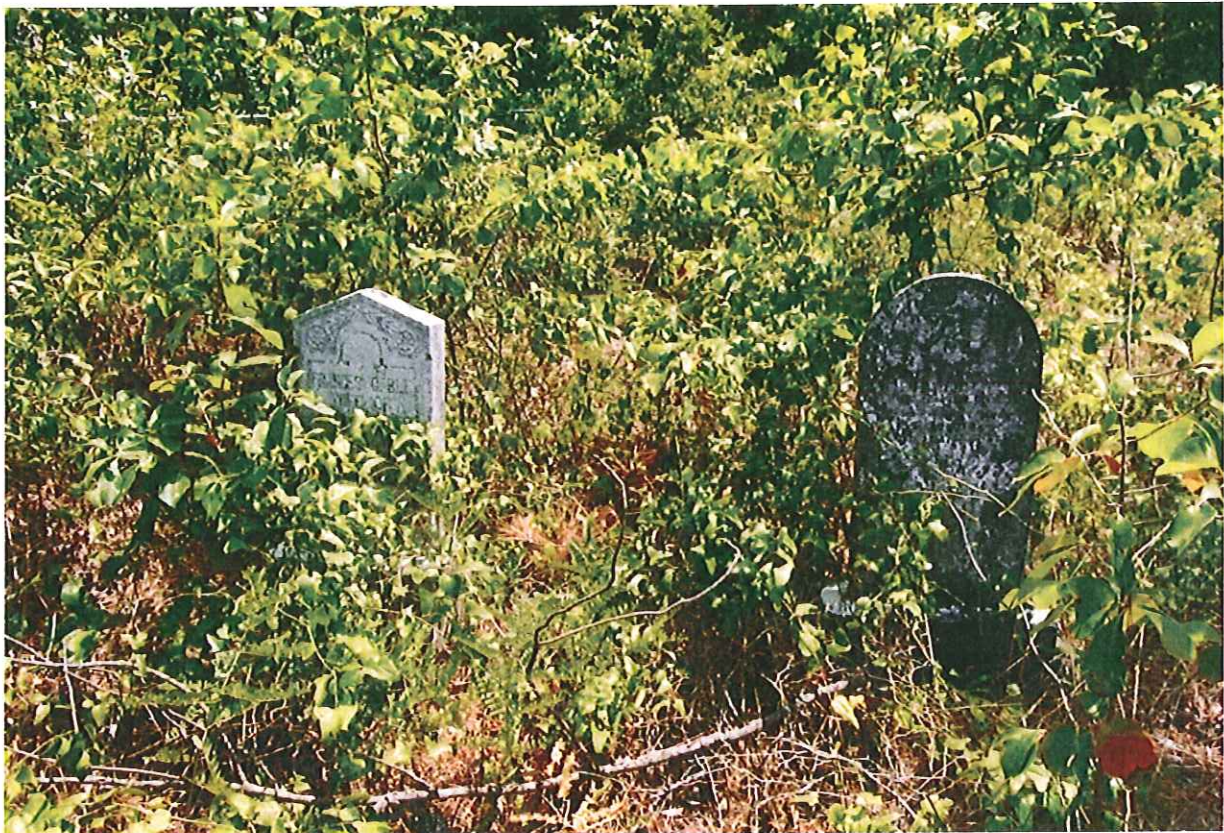
Historic Site: Yninger Cemetery (Site Number 243-0304)

Description: Cemetery in a dense wooded area near the SCE&G training center and Saluda Dam spillway; cemetery appears to be somewhat abandoned, unvisited, and neglected

Distance from Line Route: 0.90 miles / 1.45 kilometers

Field Visit & Analysis: Heavy foreground screening; line route will not be visible.

Conclusion Based on the Visual Impact Assessment and Field Visit: No View

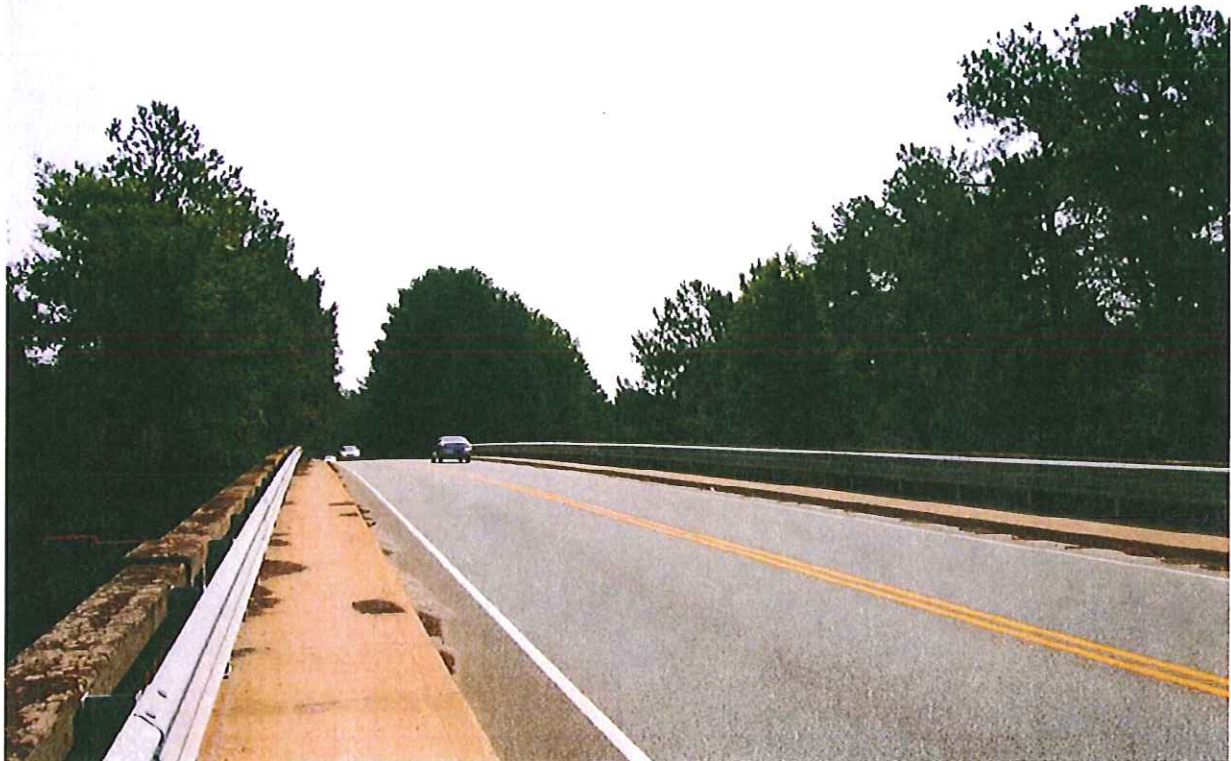
Historic Site: CSX Railroad Bridge (Site Number 426-4716)

Description: Cast concrete bridge carrying Hwy. 76 over the rail corridor

Distance from Line Route: 0.19 miles / 0.30 kilometers

Field Visit & Analysis: Heavy foreground screening; while existing lines or structures could not be seen it is possible for the bridge to have a view of the line when the leaves drop from the trees. Due to the industrial nature of the bridge and existing utilities and infrastructural elements near the bridge, it is unlikely that the existence of the line route would negatively affect the historical qualities of the site.

Conclusion Based on the Visual Impact Assessment and Field Visit: A light, insignificant view is possible during leaf-off conditions

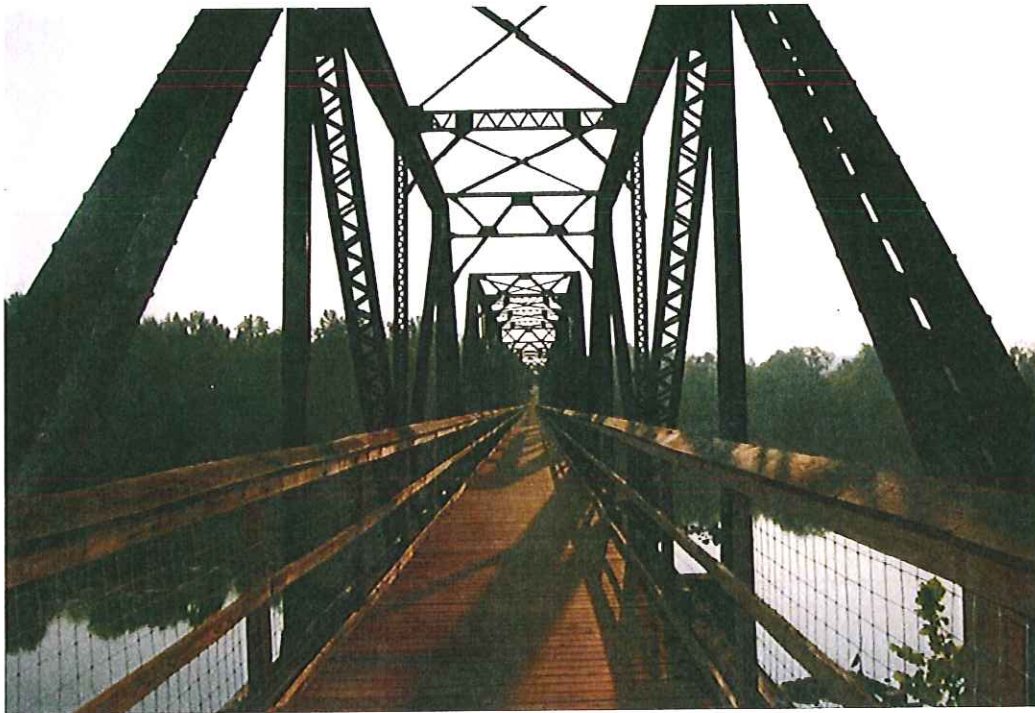
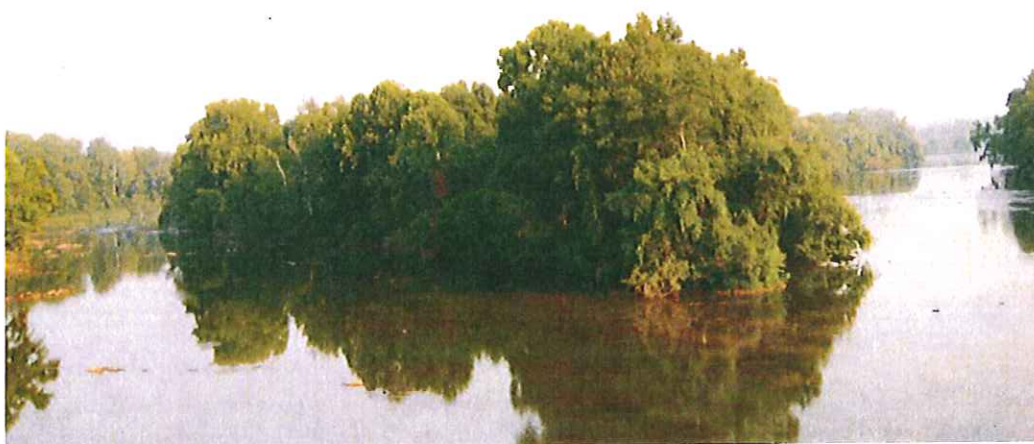
Historic Site: Harry Easterling Bridge (BA Resource 2)

Description: Railroad bridge over the broad river reclaimed for pedestrian on the Palmetto Trail

Distance from Line Route: 0.87 miles / 1.40 kilometers

Field Visit & Analysis: While heavy mid-ground screening is present, the standing height of the bridge could potentially yield a view of the line route.

Conclusion Based on the Visual Impact Assessment and Field Visit: Possible insignificant view of conductors

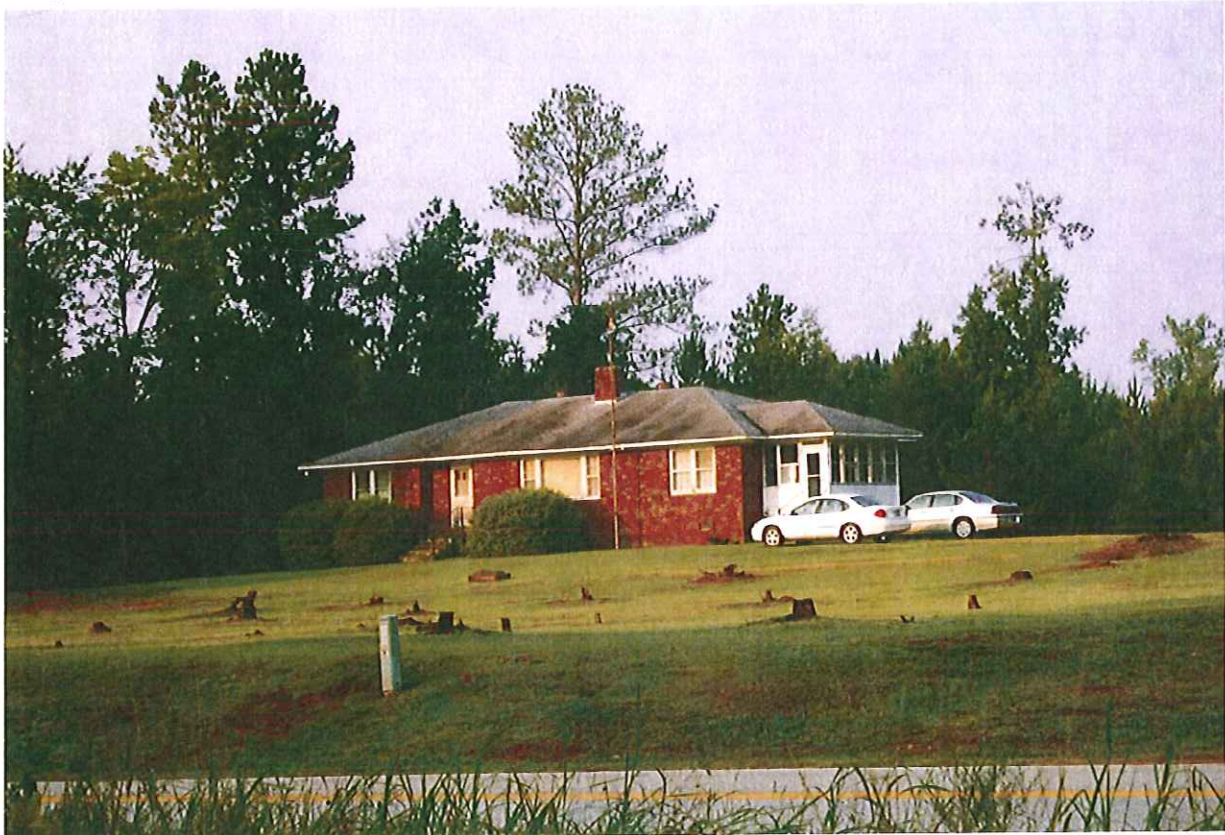
Historic Site: (BA Resource 3)

Description: Brick ranch house with enclosed porch and attached 1-car garage

Distance from Line Route: 0.7 miles / 1.15 kilometers

Field Visit & Analysis: Heavy foreground and mid-ground screening; line route will not be visible.

Conclusion Based on the Visual Impact Assessment and Field Visit: No View
